CERTIFIED ACCESS SPECIALIST (CASp) REPORT

WILLIAM S. HART DOG PARK

City of West Hollywood

Subject: CASp Report for William S. Hart Dog Park

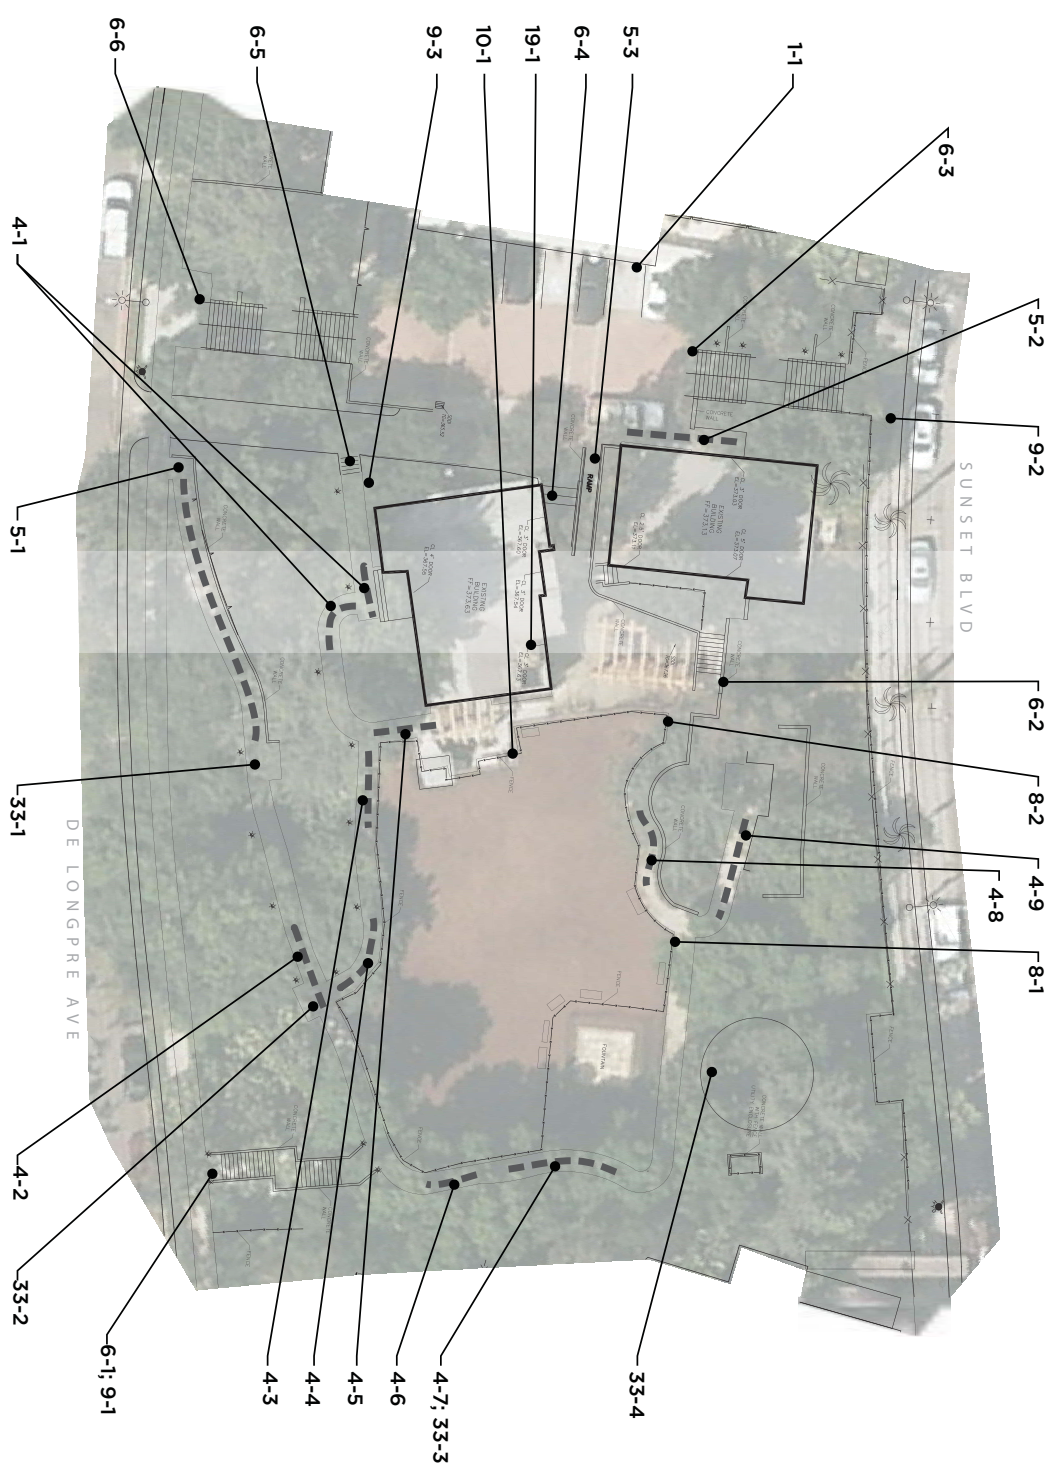
WILLIAM S. HART DOG PARK
 8341 DE LONGPRE AVE
 WEST HOLLYWOOD, CA
 PARK

The **last page** of the detailed report contains the diagram of the facility with notations regarding the barriers identified during the evaluation. The barriers are keyed on the diagram by an item letter that corresponds with a particular barrier (i.e. 4-1 is walk number one, 4-2 is walk number two, etc.). The elements and their related features addressed in the facility report include:
