# 21 PRESERVATION BRIEFS

## Repairing Historic Flat Plaster—Walls and Ceilings

Marylee MacDonald

U.S. Department of the Interior National Park Service  
Preservation Assistance Division Technical Preservation Services

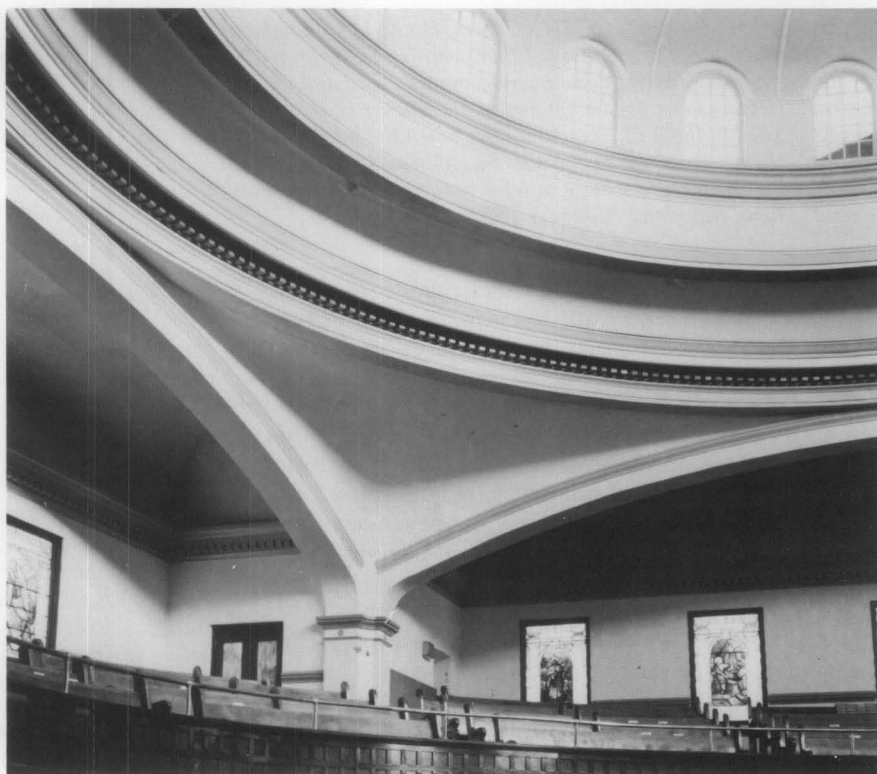
Fig. 1. Left: Schifferstadt, Frederick, Maryland, 1756. Right: First Christian Church, Eugene, Oregon, 1911. Although these two structures are separated in history by over 150 years and differences in size, ethnic origin, geography, construction techniques, and architectural character, their builders both used plaster as the interior surface coating for flat and curved walls. Photo left: Kay Weeks. Photo right: Kaye Ellen Simonson.

Plaster could be treated in any number of ways: it could receive stenciling, decorative painting, wallpaper, or whitewash. This variety and the adaptability of the material to nearly any building size, shape, or configuration meant that plaster was the wall surface chosen for nearly all buildings until the 1930s or 40s (Fig. 1).

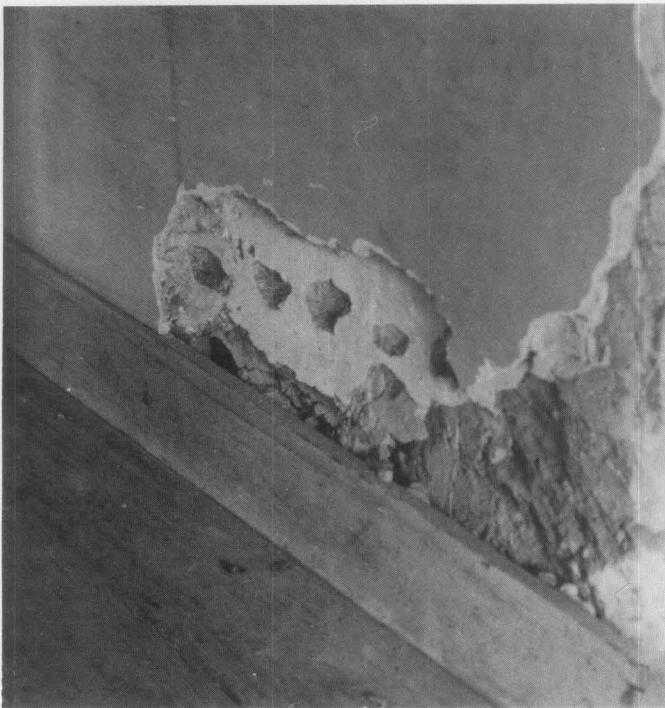
Fig. 4. The builders of this mid-18th century house installed the baseboard moulding first, then applied a mud and horse hair plaster (called *paling*) to the masonry wall. Lime was used for the finish plaster. Also shown are the hacking marks which prepared the wall for a subsequent layer of plaster. Photo: Kay Weeks.

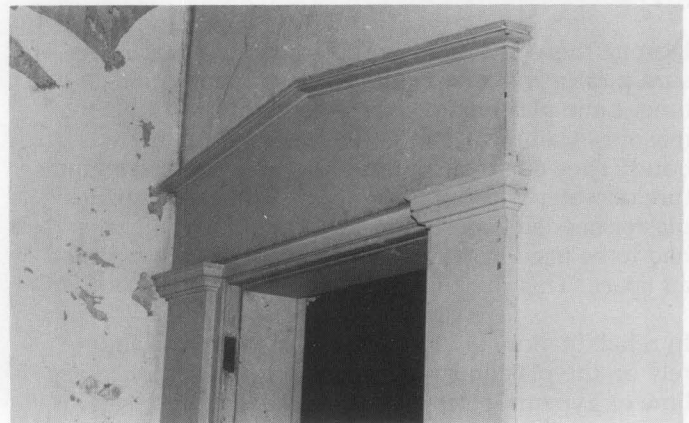
Fig. 5 (a). The photo above shows the use of wooden plaster "grounds" nailed to the wall studs of the mid-19th century Lockwood House in Harpers Ferry, West Virginia. This allowed the plasterer to work flush with the surface of the grounds. Afterwards, the carpenter could nail the finish woodwork to the ground, effectively hiding the joint between the plaster and the ground. The trim was painted after its installation, leaving a paint outline on the plaster. Fig. 5 (b). The photo below shows door trim and mouldings in place after the plastering was complete. Photos: Kaye Ellen Simonson.

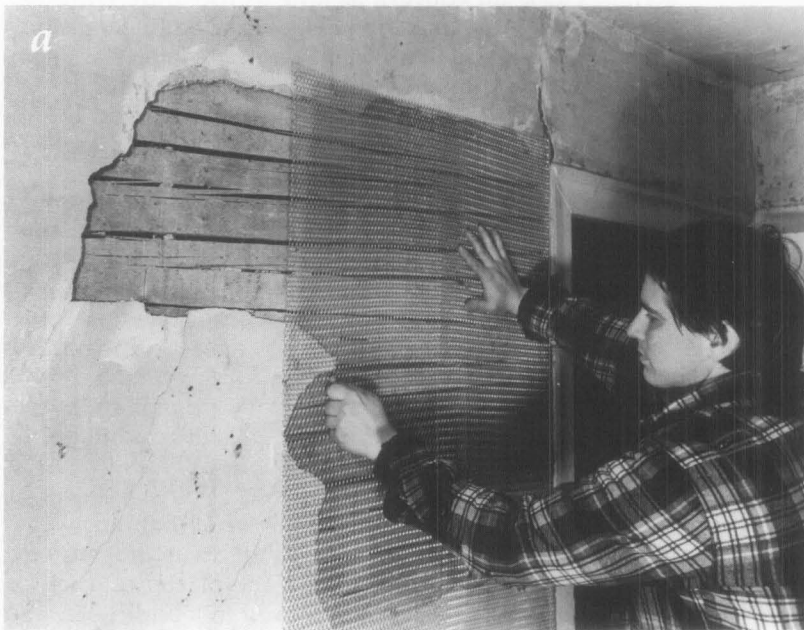
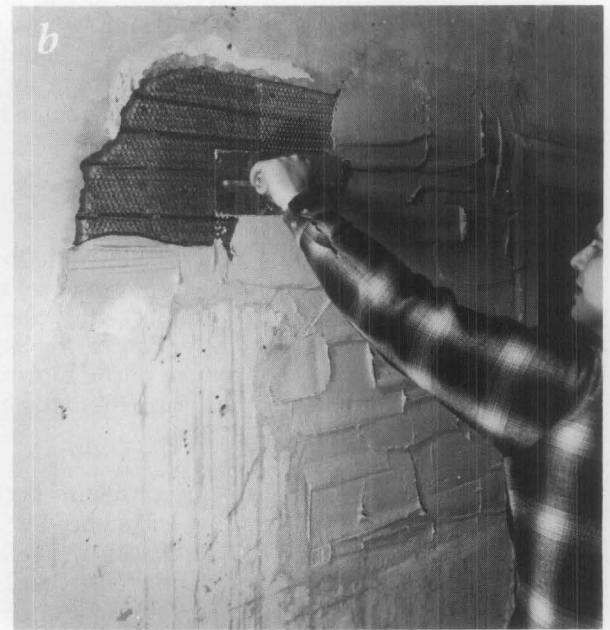
Fig. 10 (a) and (b). In this New Hampshire residence dating from the 1790s, the original plaster was a single coat of lime, sand, and horsehair applied over split lath. A one-coat repair, in this case, is appropriate. To the left: a flat sheet of galvanized expanded metal lath is placed over the patch area and an outline marked with a large soft lumber crayon. The metal lath is then cut to fit the hole and nailed to the lath. To the right: the edges of the original plaster and wood lath beneath have been thoroughly soaked with water. A steel trowel is used to apply the plaster in large, rough strokes. Finally, it will be scraped and smoothed off. Because only one coat of plaster is used, without a finish coat, a clean butt-joint is made with the original plaster. Photos: John Leeke.

For small holes (less than 4 inches in diameter) that involve loss of the brown and finish coats, the repair is made in two applications. First, a layer of basecoat plaster is troweled in place and scraped back below the level of the existing plaster. When the base coat has set but not dried, more plaster is applied to create a smooth, level surface. One-coat patching is not generally recommended by plasterers because it tends to produce concave surfaces that show up when the work is painted. Of course, if the lath only had one coat of plaster originally, then a one-coat patch is appropriate (Fig. 10).

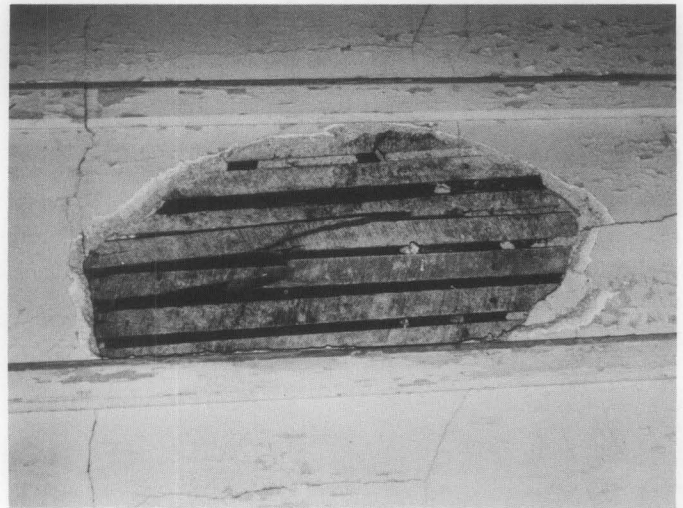
Fig. 13. This beaded ceiling in one of the bedrooms of the 1847 Lockwood House, Harpers Ferry, West Virginia, is missing portions of plaster due to broken keys. This is attributable, in part, to deterioration of the wood lath. Photo: Kaye Ellen Simonson.

Hairline cracks and holes may be unsightly, but when portions of the ceiling come loose, a more serious problem exists (Fig. 13). The keys holding the plaster to the ceiling have probably broken. First, the plaster around the loose plaster should be examined. Keys may have deteriorated because of a localized moisture problem, poor quality plaster, or structural overloading; yet, the surrounding system may be intact. If the areas surrounding the loose area are in reasonably good condition, the loose plaster can be reattached to the lath using flat-head wood screws and plaster washers (Fig. 14). To patch a hole in the ceiling plaster, metal lath is fastened over the wood lath; then the hole is filled with successive layers of plaster, as described above.

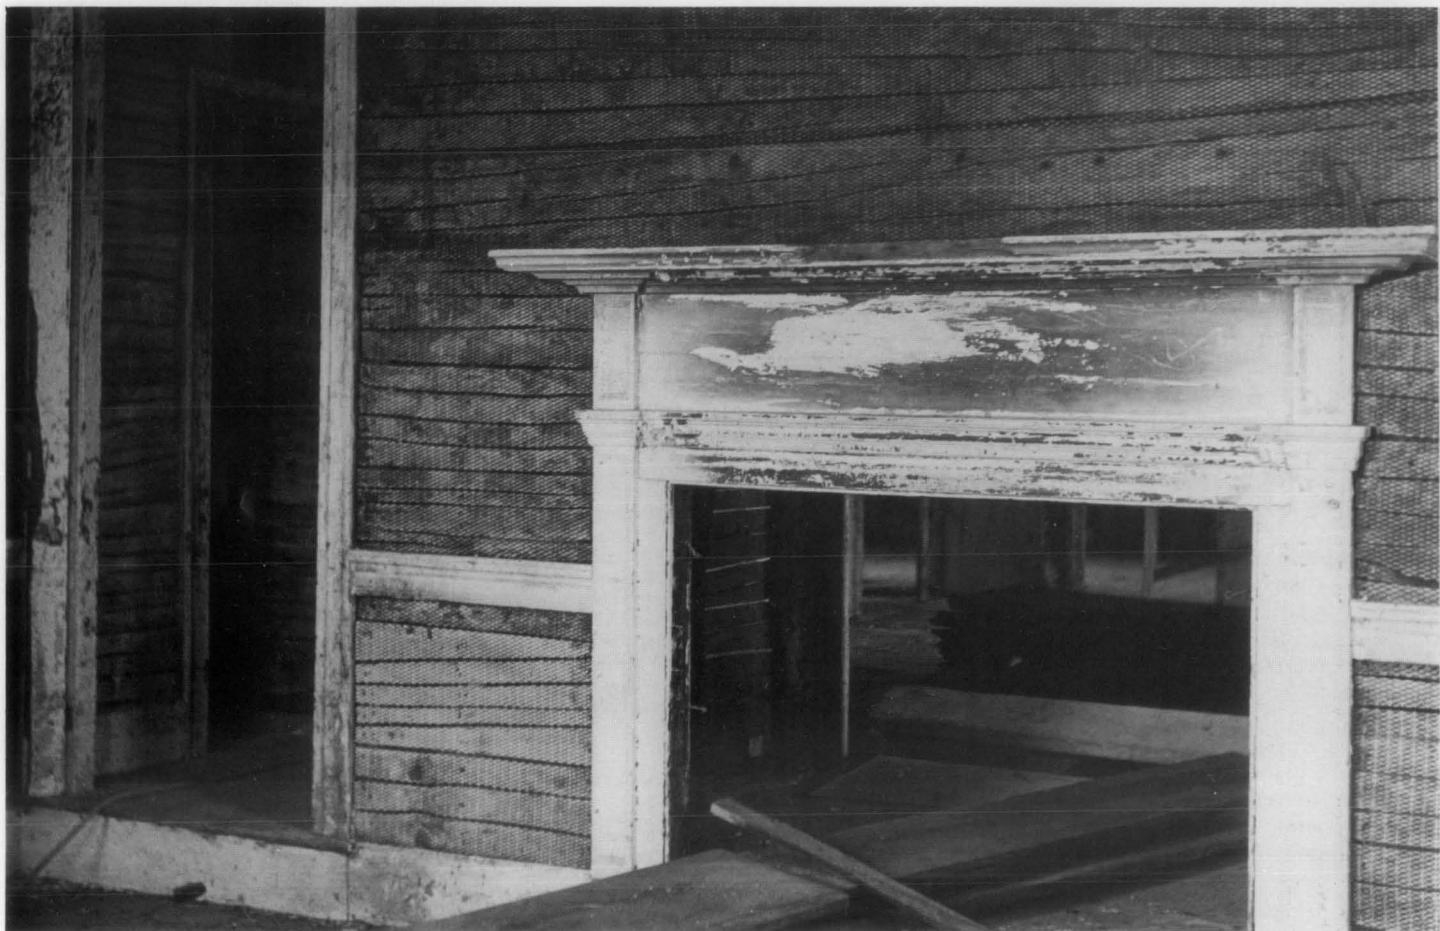
Fig. 16. In the restoration of a ca. 1830s house in Maine, split-board lath has been covered with expanded metal lath in preparation for new coats of plaster. This method permits the early lath to be saved while the metal lath, with its superior keying, serves as reinforcement. Photo: National Park Service files.

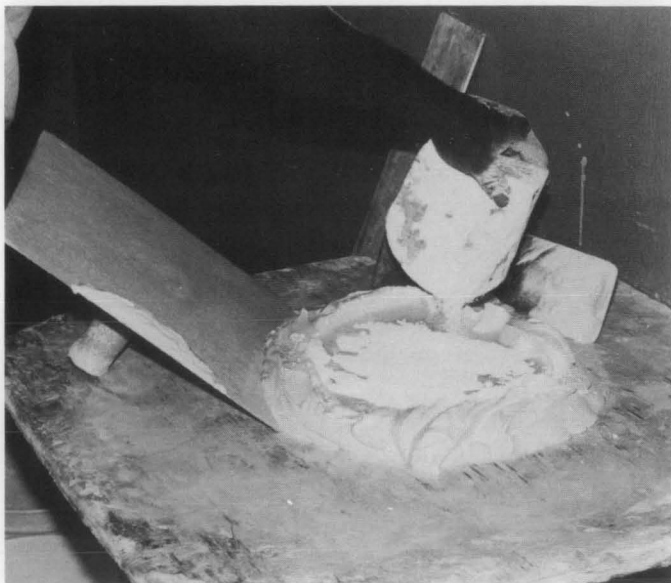
*Fig. 17. This contemporary plasterer is mixing a lime finish coat in much the same way as America's earlier artisans. The ring consists of lime putty; the white powder inside is gauging plaster. After the mixture is blended, a steel trowel will be used to apply it. It should be noted that a traditional lime finish coat can be applied over a veneer plaster base coat to approximate the look of historic plaster walls and ceilings. Photo: Marylee MacDonald.*

The system uses gypsum-core panels that are the same size as drywall (4x8 feet), and specially made for veneer plaster. They can be installed over furring channels to masonry walls or over old wood lath walls and ceilings. Known most commonly as "blueboard," the panels are covered with a special paper compatible with veneer plaster. Joints between the 4-foot wide sheets are taped with fiberglass mesh, which is bedded in the veneer plaster. After the tape is bedded, a thin, 1/16-inch coat of high-strength veneer plaster is applied to the entire wall surface. A second veneer layer can be used as the "finish" coat, or the veneer plaster can be covered with a gauged lime finish-coat—the same coat that covers ordinary plaster (Fig. 17).

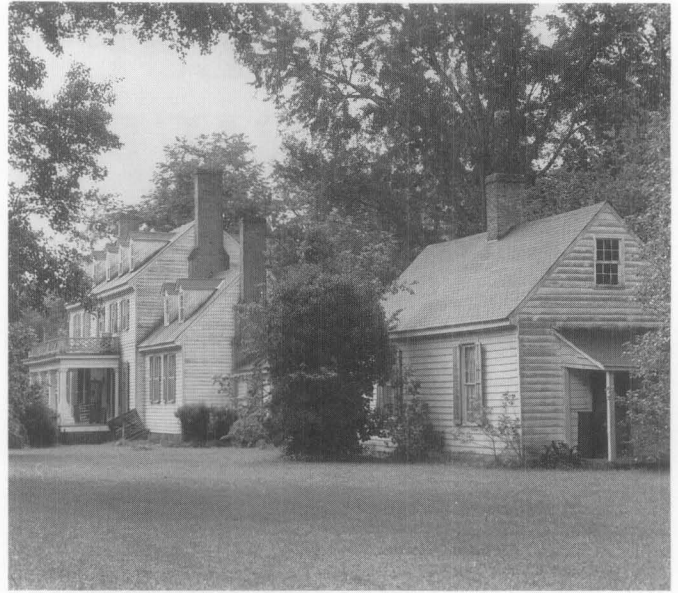
1. Eighteenth century and later vernacular architecture depended on the siting of the building, deciduous trees, cross ventilation, and the placement of windows and chimneys to maximize winter heating and natural summer cooling. Regional details, as seen in this Virginia house, include external chimneys and a separate summer kitchen to reduce fire risk and isolate heat in the summer. Photo: NPS Files.

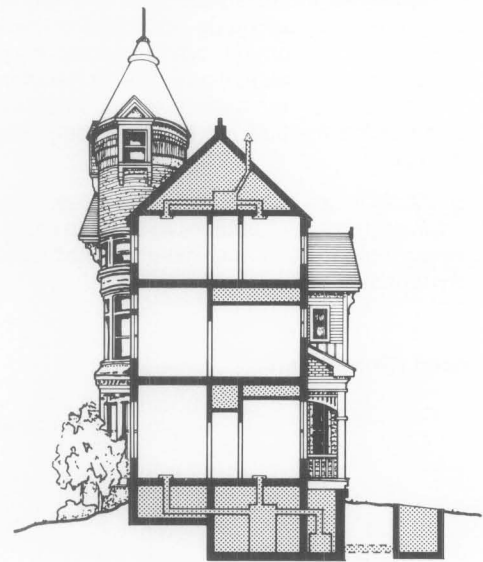
8. In considering options for new systems, existing spaces should be evaluated for their ability to house new equipment. This sketch shows several areas where new mechanical equipment could be located to avoid damaging significant spaces. Sketch: NPS files

4. **Prioritize architecturally significant spaces, finishes, and features to be preserved.** Significant architectural spaces, finishes and features should be identified and evaluated at the outset to ensure their preservation. This includes significant existing mechanical systems or elements such as hot water radiators, decorative grilles, elaborate switchplates, and non-mechanical architectural features such as cupolas, transoms, or porches. Identify non-significant spaces where mechanical equipment can be placed and secondary spaces where equipment and distribution runs on both a horizontal and vertical basis can be located. Appropriate secondary spaces for housing equipment might include attics, basements, penthouses, mezzanines, false ceiling or floor cavities, vertical chases, stair towers, closets, or exterior below-grade vaults (see figure 8).

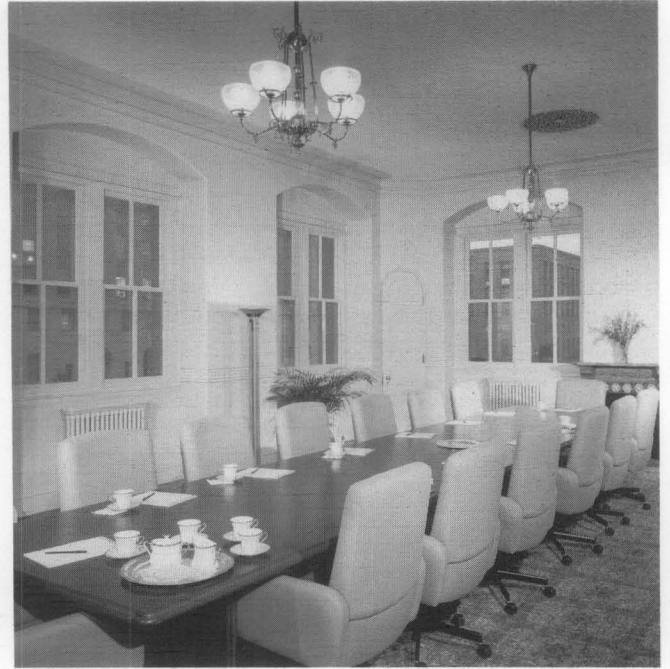
c. Conference room, Auditors Building, Washington, D.C. The historic steam radiators were retained for heating. The cast iron ceiling register was retained as a decorative element, but made inoperable to meet fire codes. Photo: Kenneth Wyner Photography courtesy of Notter Finegold + Alexander Inc.

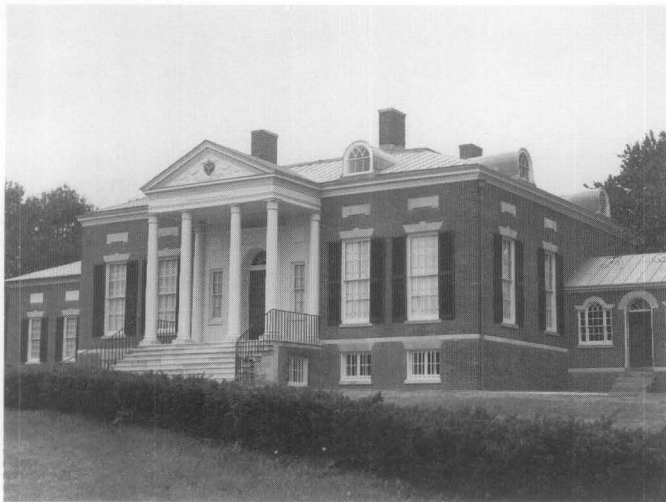
11. During the restoration of this 1806 National Historic Landmark (photo a), a new climate control system was installed. The architects removed all the earlier mechanical equipment from the house and installed new equipment in a 30' × 40' concrete vault located underground 150 feet from the house itself (photo b). Only conditioned air is blown into the house reusing much of the circa 1930s ductwork. Photos: Thomas C. Jester.
